LEO MICROMETEORITE/DEBRIS IMPACT DAMAGE*

Paul M. Stella
 Jet Propulsion Laboratory
 California Institute of Technology
 Pasadena, CA 91109

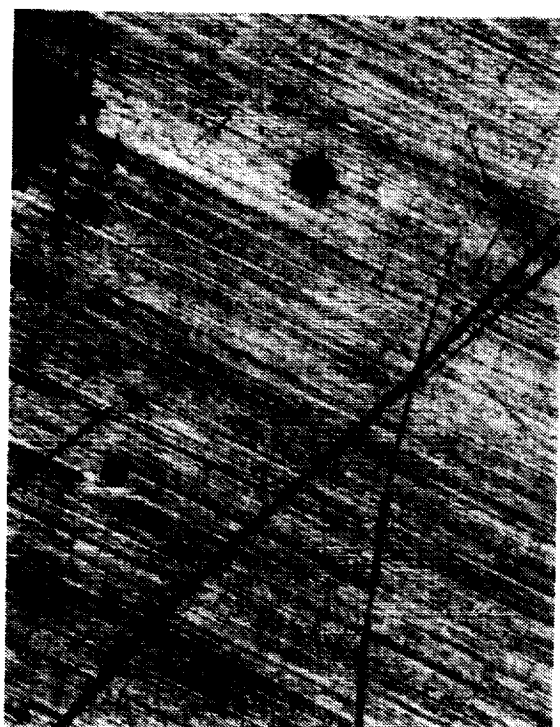
Survey of the plate reveals a large number of impact craters, predominantly in the aluminum plate, ranging in size from 0.05 mm (Figure 3) to 1 mm (Figure 4) in diameter. Most impacts appear to be normal to the plate (circular crater), although a small number of elongated craters indicate off normal incidence. The physical appearance of these impacts is discussed in the following section.

Figure 3. Typical small Al craters
~0.05mm diameter

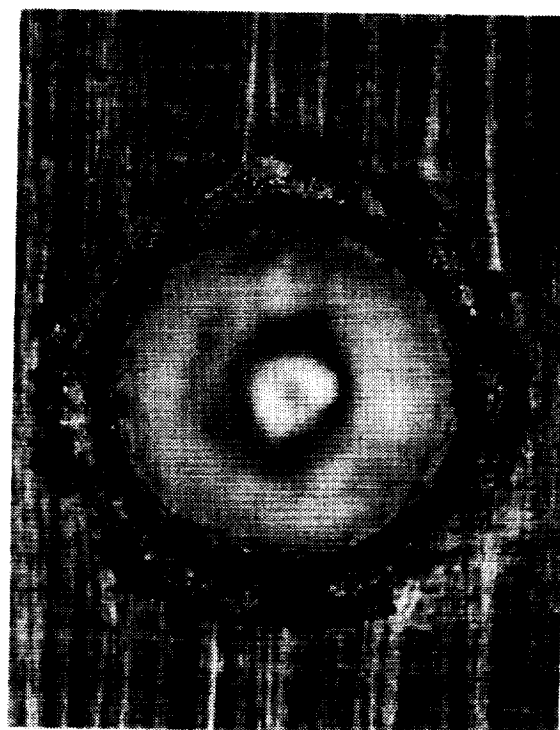
Since the majority of the test plate area consists of the uncovered aluminum mounting plate, the majority of impacts are located in the plate. These are generally similar visually, and typified by the example in Figure 4. The impact has formed a circular crater with a surrounding ridge ejected out from and over the plate surface. The crater bottom is crystalline in appearance, unlike the scratched and machined plate surface, showing evidence of melting and resolidifying. This crater pattern was observed for all sizes from 1mm diameter on down. Of the 157 impacts observed (over the entire test plate/sample surface), seven were 0.5mm or larger. Depth measurements of the seven indicated a crater depth (measured from crater bottom to top of surrounding ridge) ranging from one-half to one-third the crater diameter. Only a few craters were noted with an elliptical shape that might be attributable to an impact with a particle with a large non-normal velocity component.

Figure 4. Largest crater ~1mm
diameter

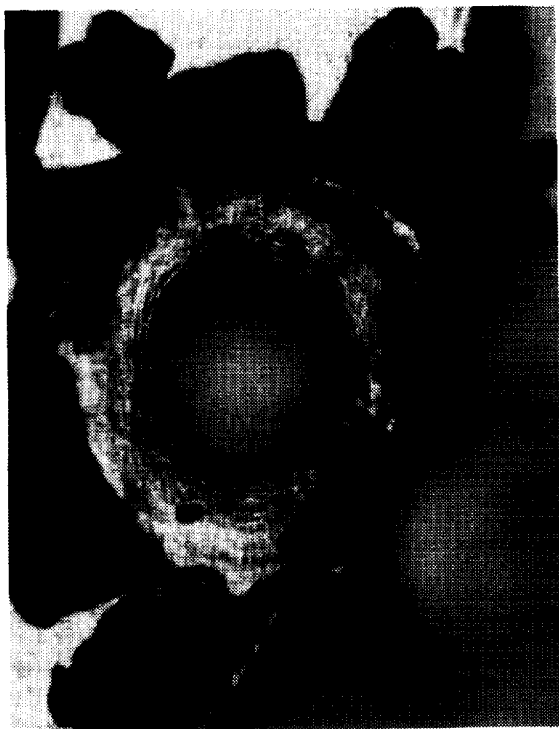
Although the total area occupied by the silver-plated Invar tabs was relatively small, the debris/micrometeorite fluence was sufficient that tab impacts did occur. The results of the impacts were visually surprising, but offer clear indication of the high particle impact velocities and corresponding impact energies. Figure 5 is a typical example of one such impact. It is observed that the tab has been completely penetrated. The region of Invar immediately surrounding the 0.5mm diameter through hole shows clear indication of melting and resolidifying. In addition, the impact generated gases have peeled the top silver plating away from the Invar and blown those layers out from the impact area. The silver/Invar separation is well-identified by the lack of any atomic oxygen darkened residual silver. Indeed, the inner surface of the peeled back silver plating has now darkened from atomic oxygen interaction. The remainder of the silver plated Invar tab still appears shiny due to a thin layer of silicone adhesive which has provided protection during the mission. This kind of impact well illustrates the nature of the typical LEO particulate impacts -- small and violent.

Figure 5. Invar Interconnector
(~0.2mm diameter hole)

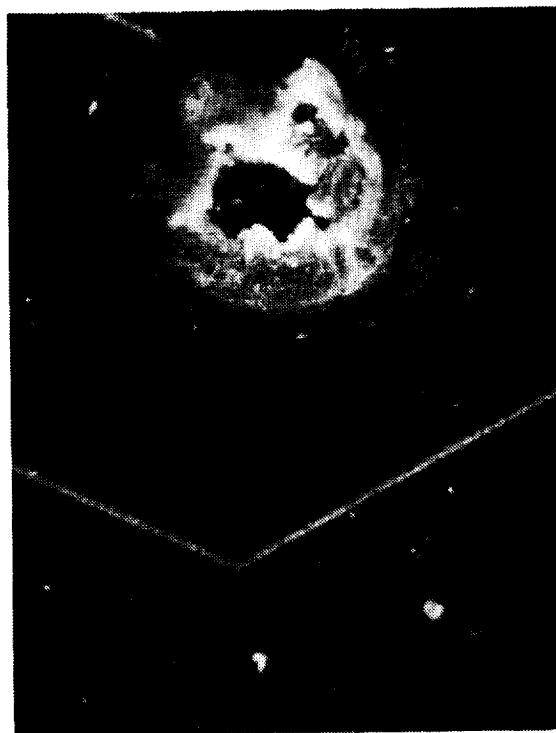
The appearance of impacts with a relatively thick polymer cell cover, such as Teflon FEP, shown in Figure 6, is remarkably similar to

the above-described silver-plated Invar tab. For Teflon, the incident particle readily penetrates and impacts the silicon cell below. The impact with the silicon has generated gases which, in turn, lift the Teflon away from the cell and blow out the central area. The flexible Teflon, unlike the rigid silver metallization, settled back somewhat onto the cell surface. A light colored ring can be observed around the blowout region, corresponding to an area of Teflon/silicon delamination, where physical contact has been recovered, if not adherence. It is clear that the Teflon provides essentially negligible protection against the high energy impacts. Again, due to the small damage area, cell power degradation may not be significant. It is intended to examine for any impact/cell power loss correlation in subsequent electrical performance tests.

Figure 6. Teflon cover (~0.3mm
diameter hole)

Although polymer-type covers may look attractive for low cost cell protection and may someday be suitable for protection against U.V. and low energy protons, there is negligible ability to shield against debris/micrometeorite impacts. If these impacts are cell degrading, then more robust covers, such as the standard fused silica or microsheet materials may be required at these low altitudes.

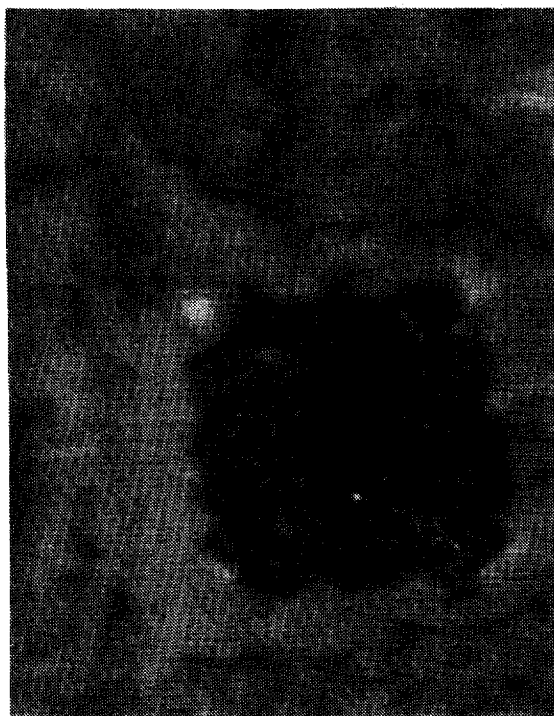
The silicon and microsheet impacts are discussed together because of the many similarities. Both materials are rigid and tend to shatter under severe loading. Figure 7 is a photograph of an impact in silicon (through a few micron thick polymer cover) and Figure 8 is a view of an impact into a microsheet coverslide. Both impact areas are comparable in size (~0.1mm central "hole"), the difference in the photographs being due to different magnification levels. In view of the limited number of such impacts, it is not clear if these are truly typical. However, both materials have a well-defined crater with any ejected material blown completely away. Both crater perimeters appear rectangular. For the silicon, this would reflect the crystalline nature of the material, however, this would not be expected for the microsheet. Of interest, the silicon cell has been completely penetrated, with the formation of a near hexagonal through hole. The microsheet impact appears well limited in size, and radiating cracks were not visible. In the case of the microsheet impact, it was not possible to determine with certainty that damage was limited to just the microsheet and immediately underlying silicone adhesive. However, it is believed that the impact was spent in the microsheet and that the adhesive was able to absorb any residual gas/debris, without a significant silicon interaction.

Figure 7. Impact in silicon
(~0.1mm diameter hole)
